Castroville Community Services District

Moss Landing Sewer System Risk Assessment

FINAL

OCTOBER
2017

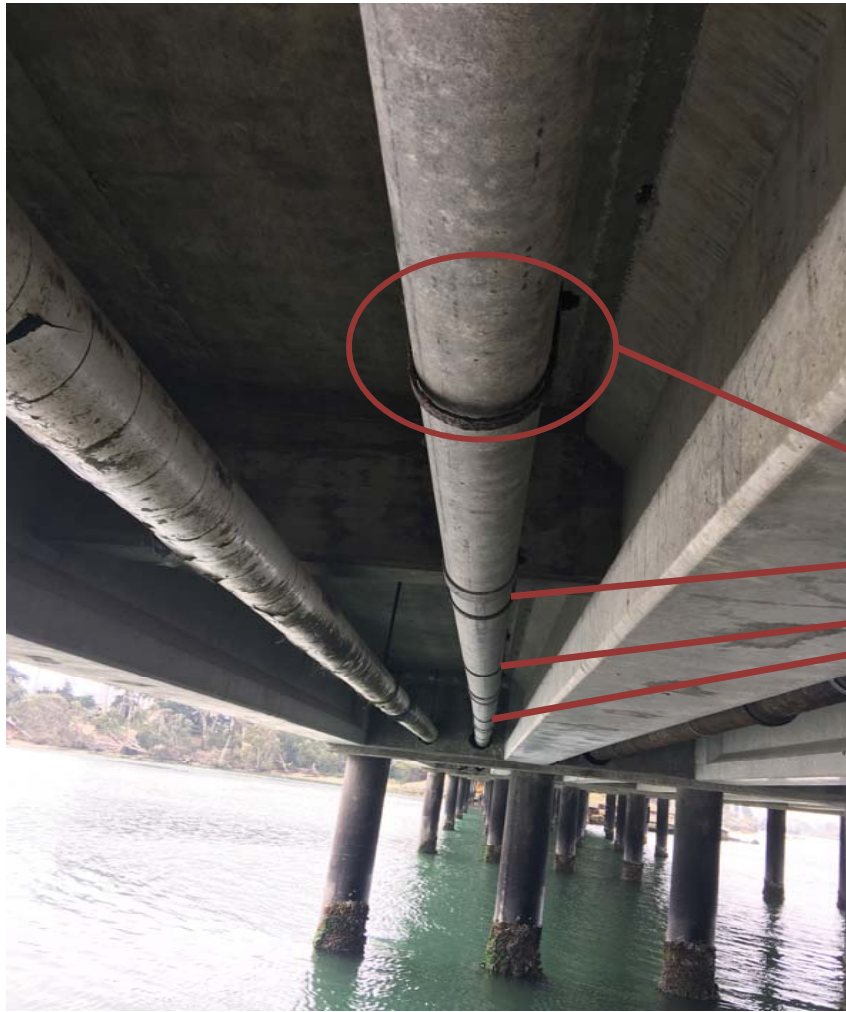
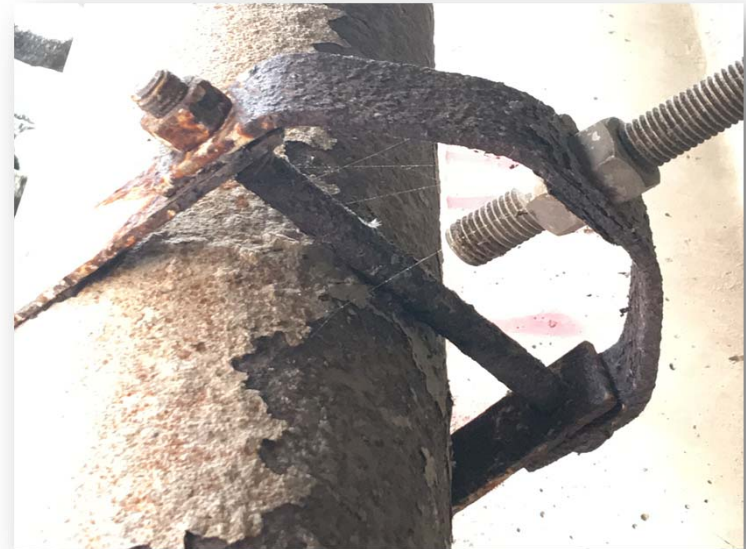
Figure
Hanger Condition
Moss Landing Risk
Assessment
Castroville Community
Services District

Additionally, the force main crossing the Elkhorn Slough was assessed during a site visit. This pipeline was prioritized for inspection due to exposure to the elements, and environmentally sensitive surroundings. The portion of the force main crossing the bridge deck is suspended by used of steel hangers. These hangers have experienced weathering and corrosion due to their exposure, and are considered beyond their useful life ([Figure 3](#)).

- **FM2-1.** Replace the section of 4-inch force main from LS-2 of the State Route 1 bridge crossing the Elkhorn Slough to approximately 1,250 feet south of the bridge. This pipeline has experienced significant corrosion within the carrier pipe in the bridge abutment, and marginal corrosion in the sections exposed under the bridge deck. Additionally, the hangers are corroded and need replacing. This project should also replace the force main discharge at manhole 14.

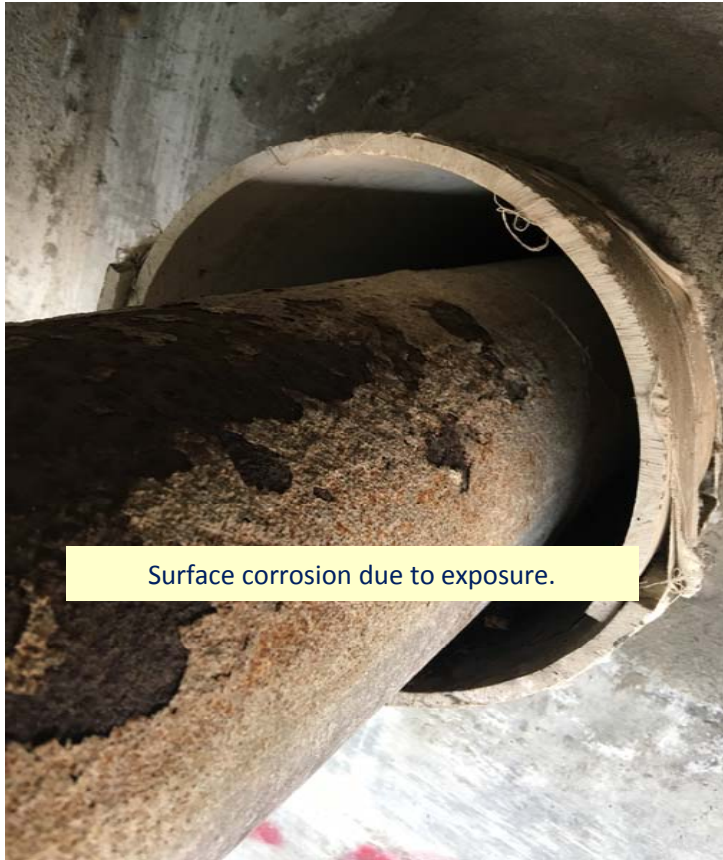
Surface corrosion due to exposure.

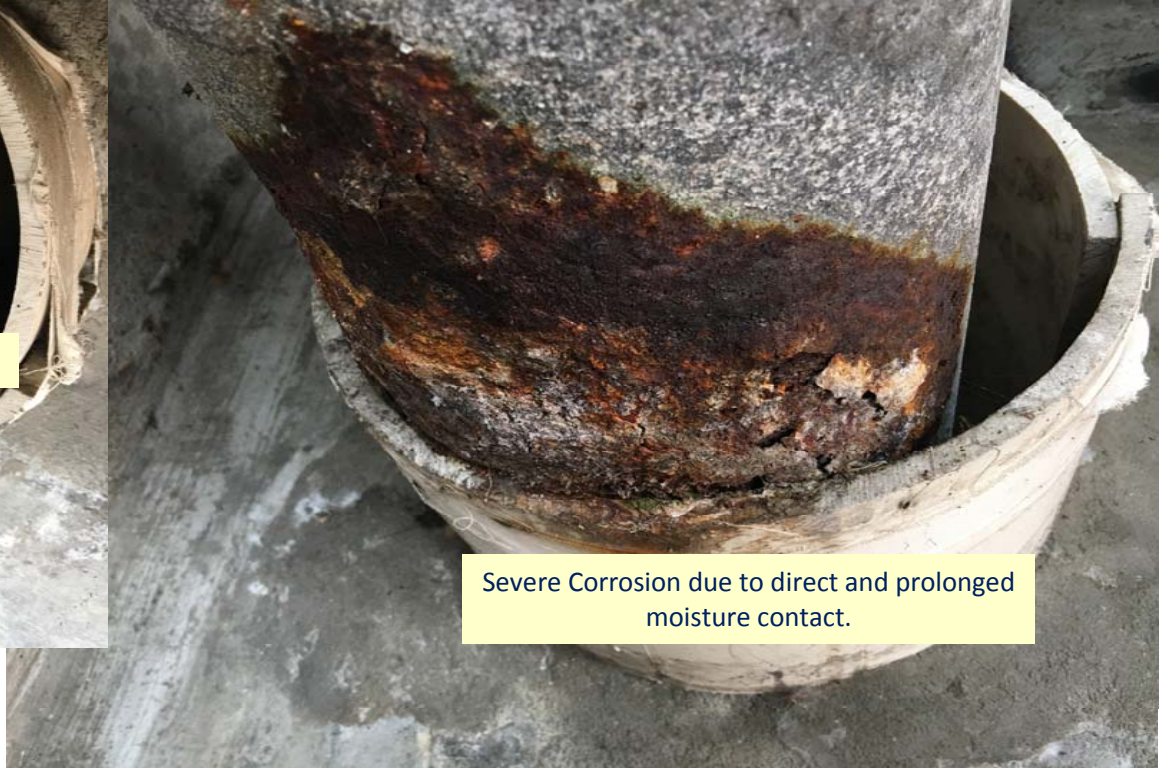
Figure
Force Main Condition
Moss Landing Risk Assessment
Castroville Community Services
District

The portion of the force main that extends into the bridge abutment and piling foundation structures appears to rest on the bottom of the sleeve. Moisture between the sleeve and the steel force main has severely corroded the bottom portion of the force main ([Figure 4](#)).

Severe Corrosion due to direct and prolonged moisture contact.

It should be noted that the condition of the force main beyond the bridge abutments is unknown. In the course of design review, it is recommended that additional locations be potholed to determine the extent of the deterioration of the force main.

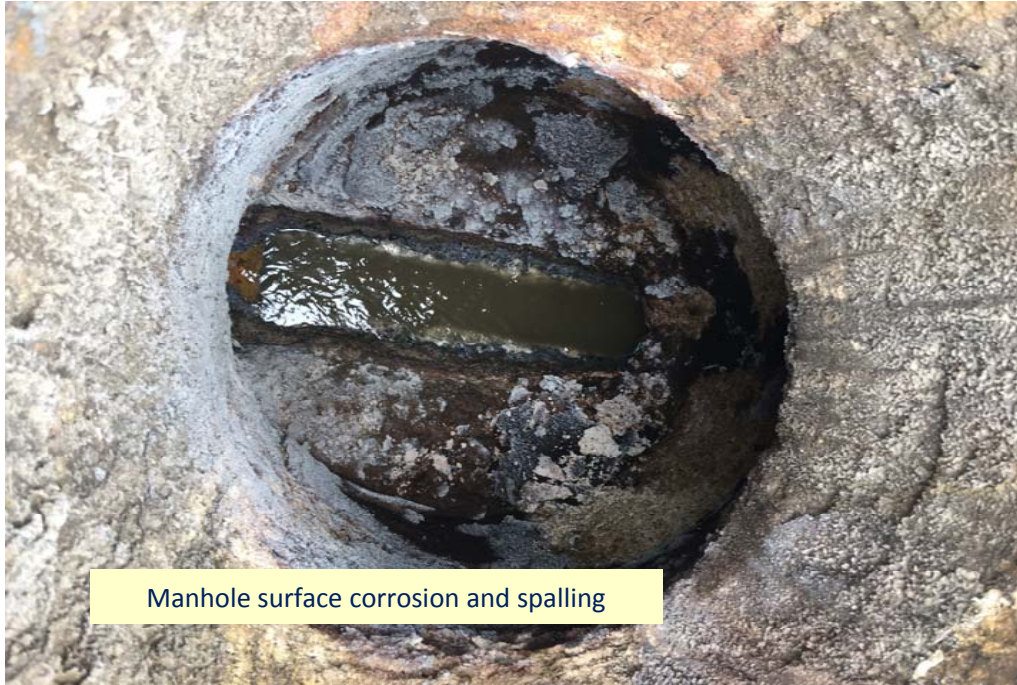
Figure 1
Manhole Co
Moss Landing Risk Assessment
Castroville Community Services
District

Finally, District staff indicated that several manholes were corroded due to sulfide gas. The District recently rehabilitated manholes 29 through 27. However, no protective coating was applied. Additionally, manholes 26 through 47 have not been rehabilitated. These manholes have experienced significant spalling, and with the rebar exposed in some cases ([Figure 5](#)). As such, these manholes are considered beyond their useful life and close to failure.

Manhole surface corrosion and spalling

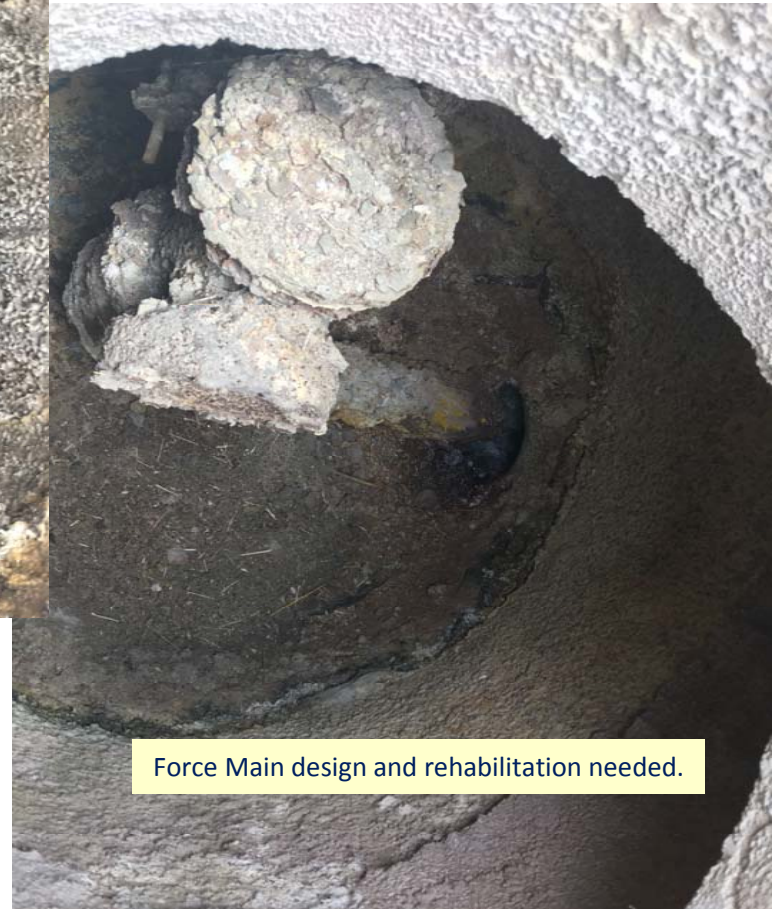
Force Main design and rehabilitation needed.

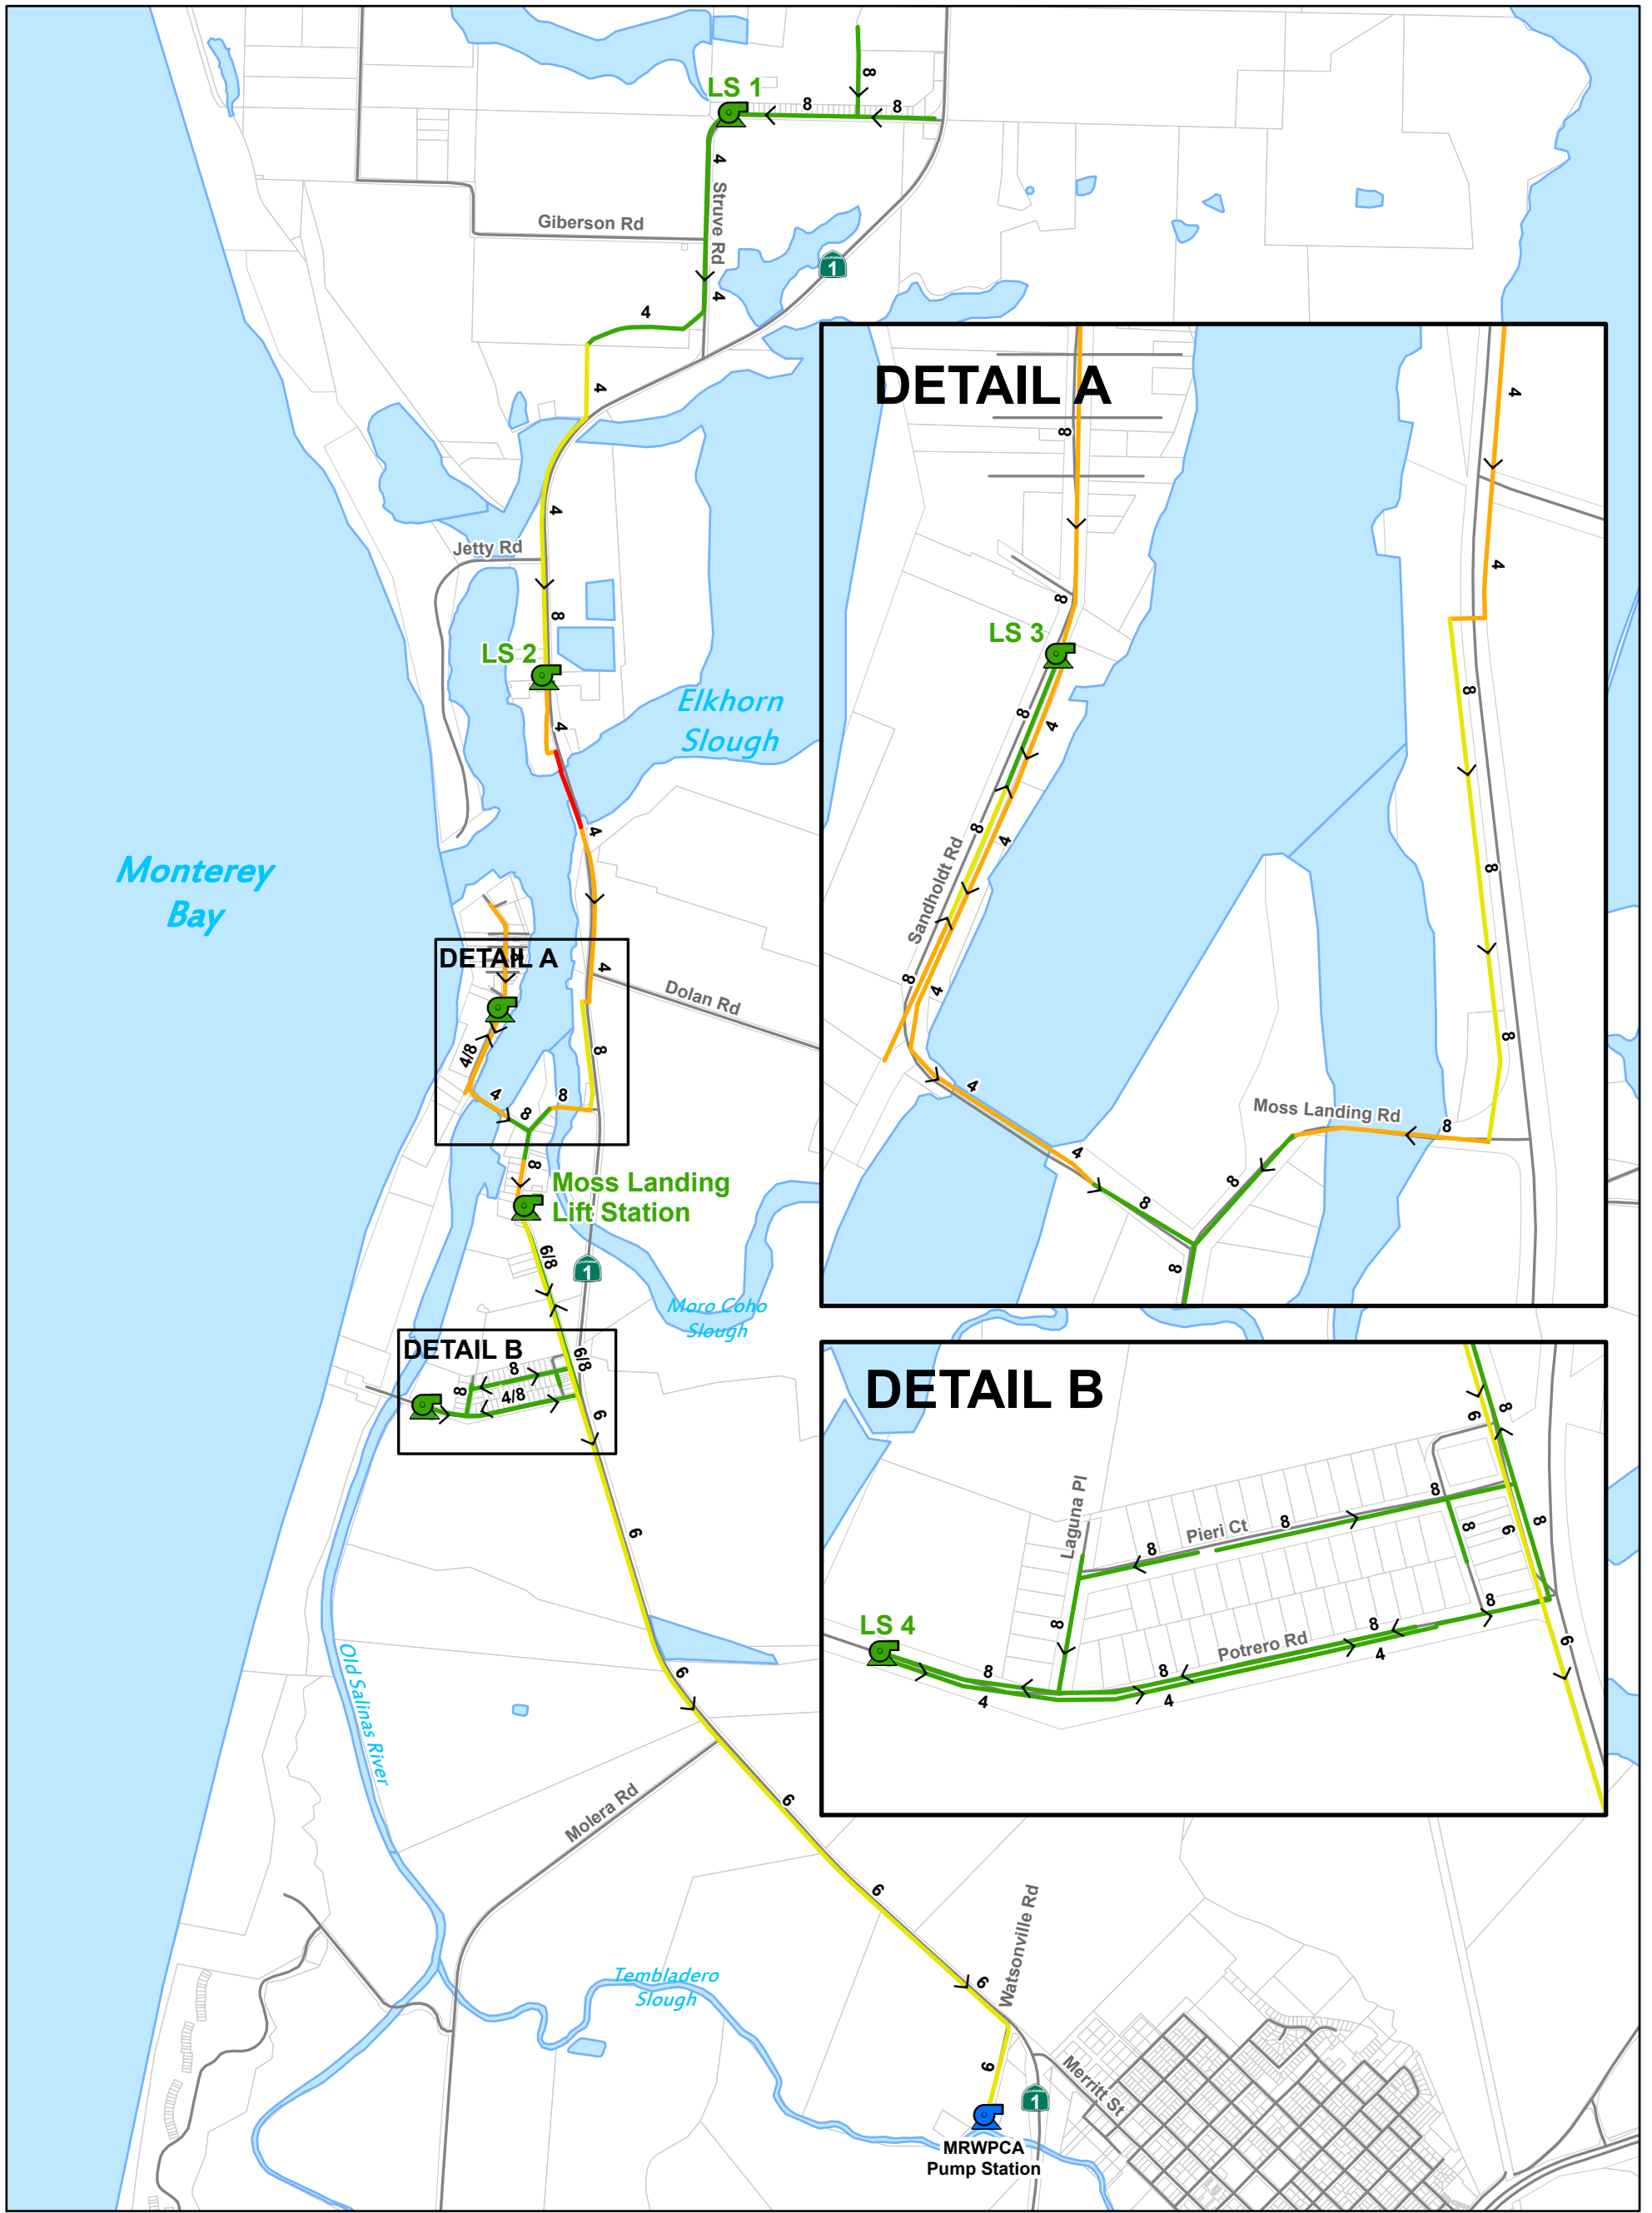
Figure 6
Pipeline Risk Assessment
 Moss Landing Risk Assessment
 Castroville Community Services District

The risk scores were combined into 3 separate categories: low, medium, and high ([Figure 6](#)). The high-risk pipelines represent the most critical assets in the system. Failure of these assets results in the largest impact to customer level of service and environmental hazards.
